# Appendix E

## Dobroth Design, Inc. Science Report

*S/V Cynthia Woods*

**The purpose of this Science Report is to examine why the keel-to-hull joint of the S/V *Cynthia Woods* failed catastrophically, thereby causing the keel to fall off the vessel during a race. The firm was retained by Texas A&M University at Galveston to determine the cause of the accident.**

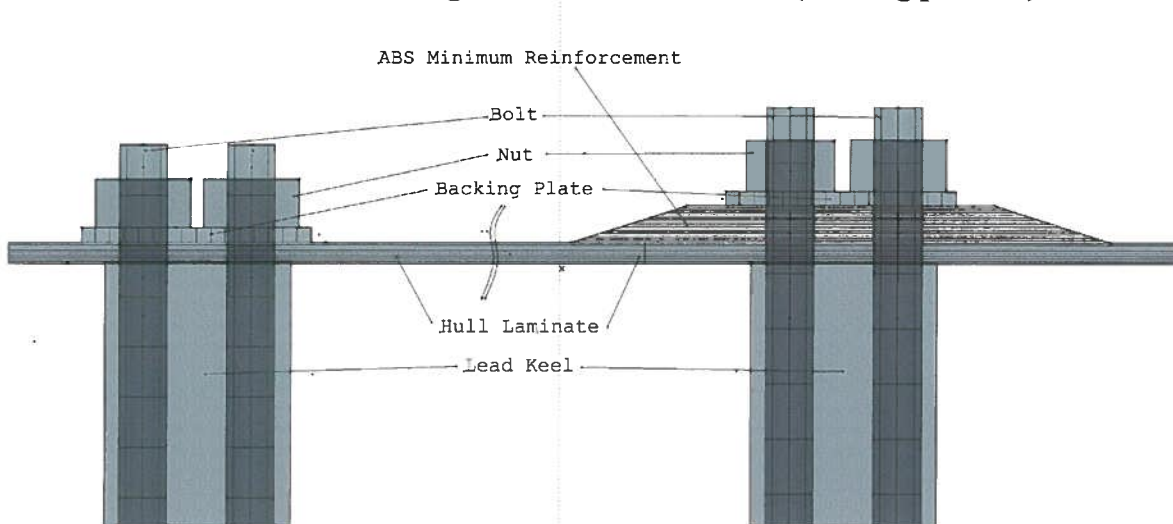
### Diagram of center keel bolts (backing plate #2)

Cross section at a pair of split bolts (split from centerline) like those that were used at plate #2. The left shows the S/V *Cynthia Woods* as-built. It is at the edge of the backing plate that the keel laminate first failed. The diagram on the right above shows the minimum laminate that is required by the ABS Guide.

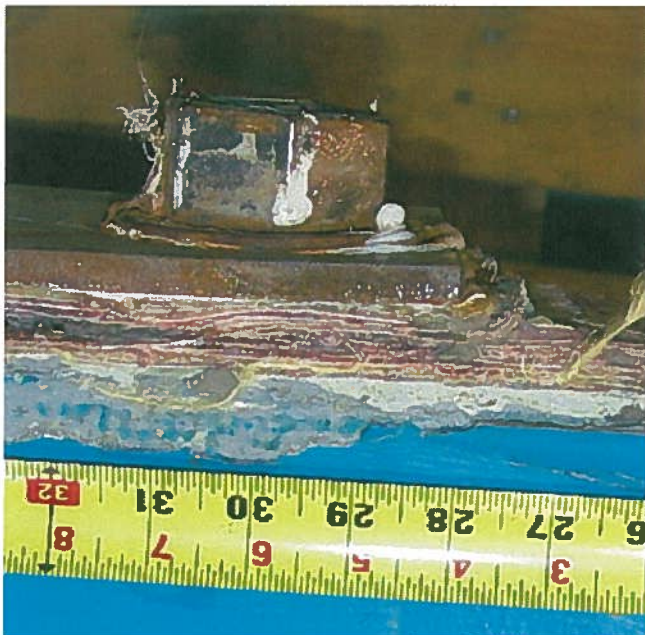
**Photo.** This photo is taken from the side of the keel. The picture shows a 1 ½" bolt through ½" to 9/16" of hull laminate. Backing plate is 3/8" thick for comparison. The pink colored material is the fiberglass laminate which is just a little thicker than the plate. The plate does not add strength, it is used to distribute load. The blue is the keel. You can see the sheared (clean, straight cut) fiberglass laminate.

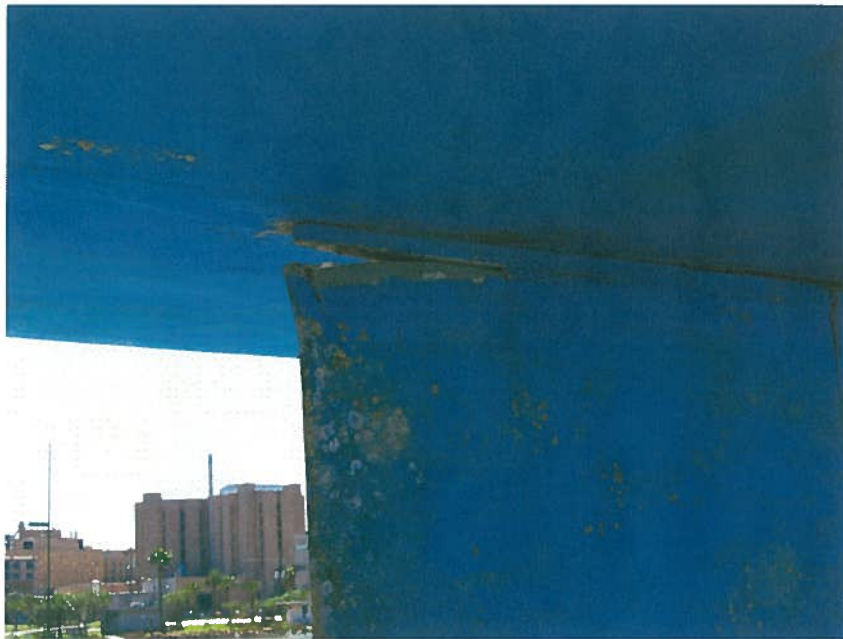
**Photo.** This is a photograph of the S/V *Cynthia Woods* after the grounding that was later repaired by the boatyard. The grounding damage in this photo is on the trailing edge of the keel. The thin, unsupported section (not attached to hull by bolts) is the trailing edge deforming lead material, which is a common occurrence in all groundings. The deformation stops at the furthest aft keel bolt. Shown above, the deformation below the hull is the fiberglass shim or spacer plate. This plate is used to “marry” the flat poured lead keel to the curved hull. Although this shim transmits load, it adds no structural strength.

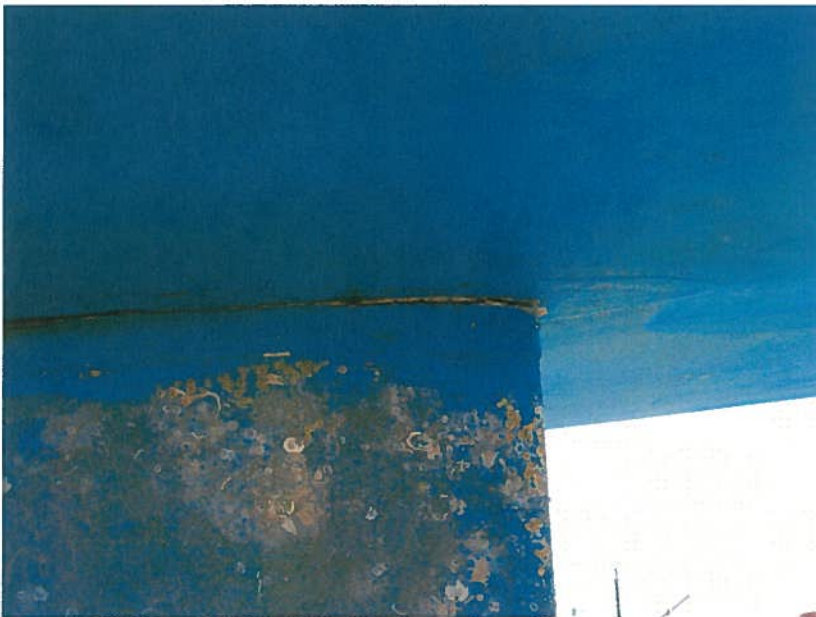
**Photo.** This is a photograph taken at the same time, showing the separation of leading edge of the keel. This deformation of the unsupported lead material occurs forward of the location of the forward keel bolt. The *Yacht Design Principles* establishes a minimum area of keel bolts in the forward 25% of the keel. This area in the S/V *Cynthia Woods* was less than recommended.

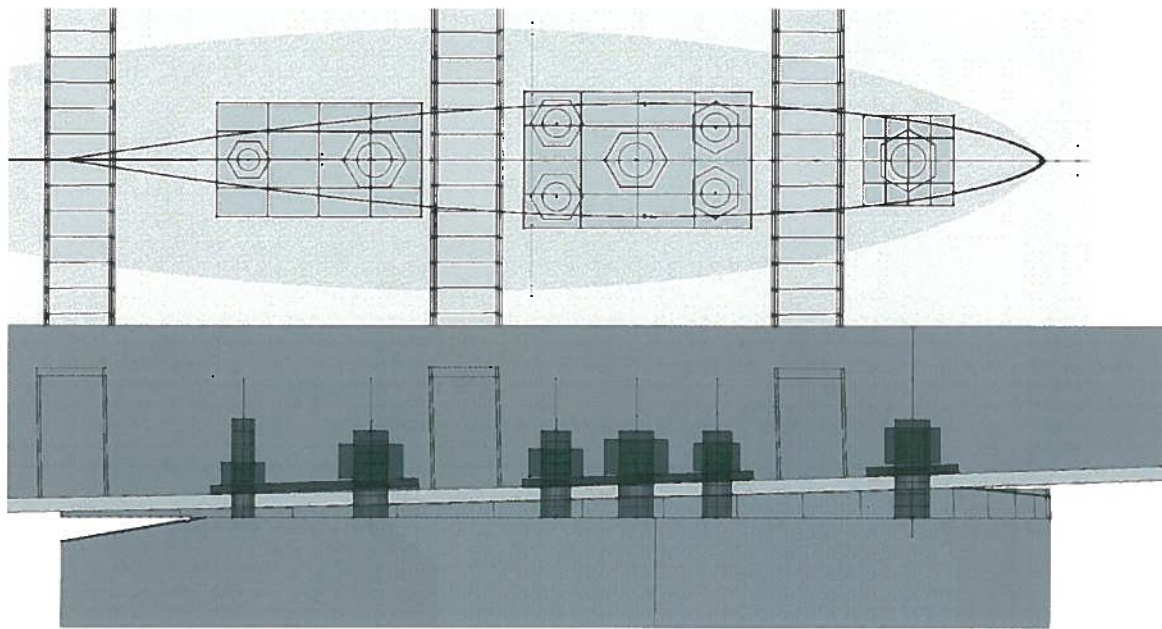
**Diagram showing the damaged locations after grounding.**

The damage to the lead is isolated to forward of the forward keel bolt and aft of the aft keel bolt. There is very little lead area aft of the last keel bolt and it is easily deformed. This type of damage is very common in groundings with a lead keel.

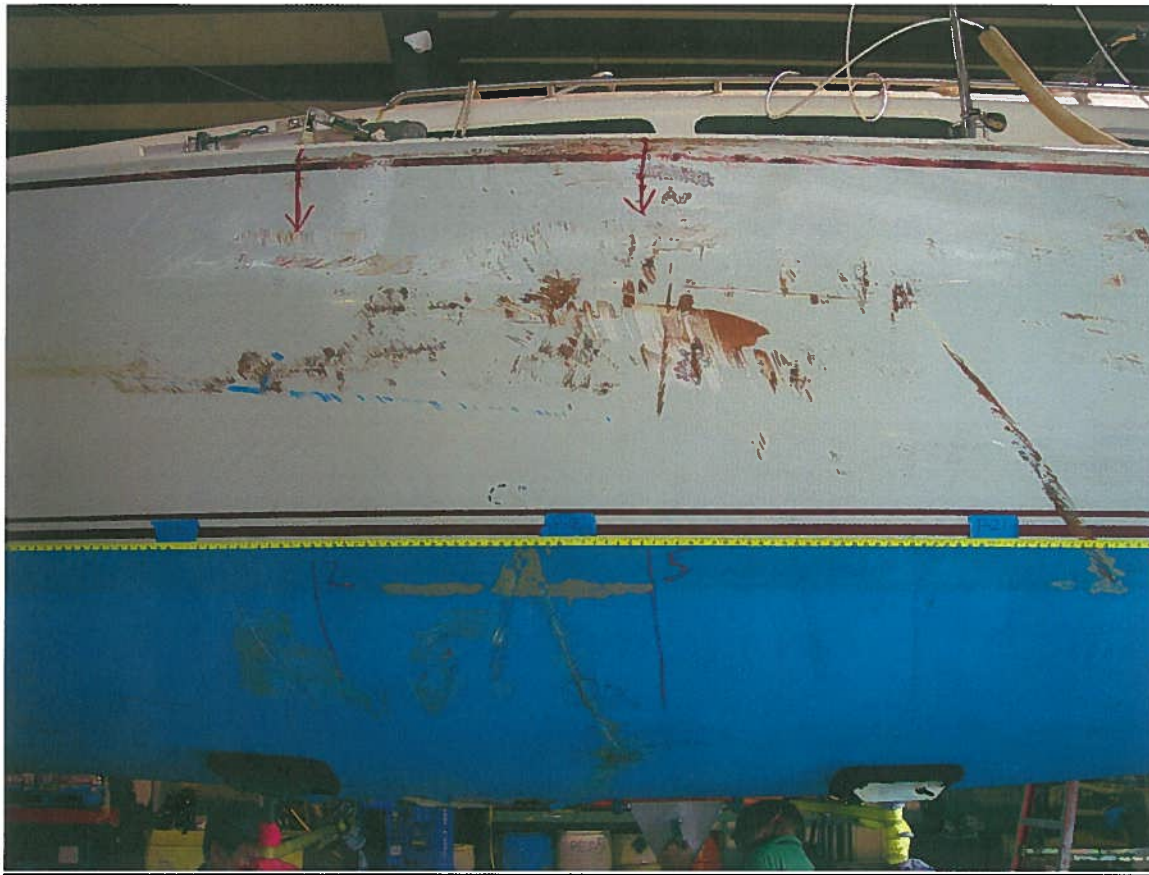
There were large external and internal cracks both left on and in the hull after towing.

**Photo.** There was major damage to the *S/V Cynthia Woods* when it was towed in from the sea. There are large cracks through the hull from below the waterline to the sheer line (top of hull). When the tow vessel approached the hull, it was floating only about one foot above the water. In the overturned condition and being full of water, it weighed over 70,000 lbs. At this weight, it was easily damaged. You can see at each crack an impact from the tow vessel.

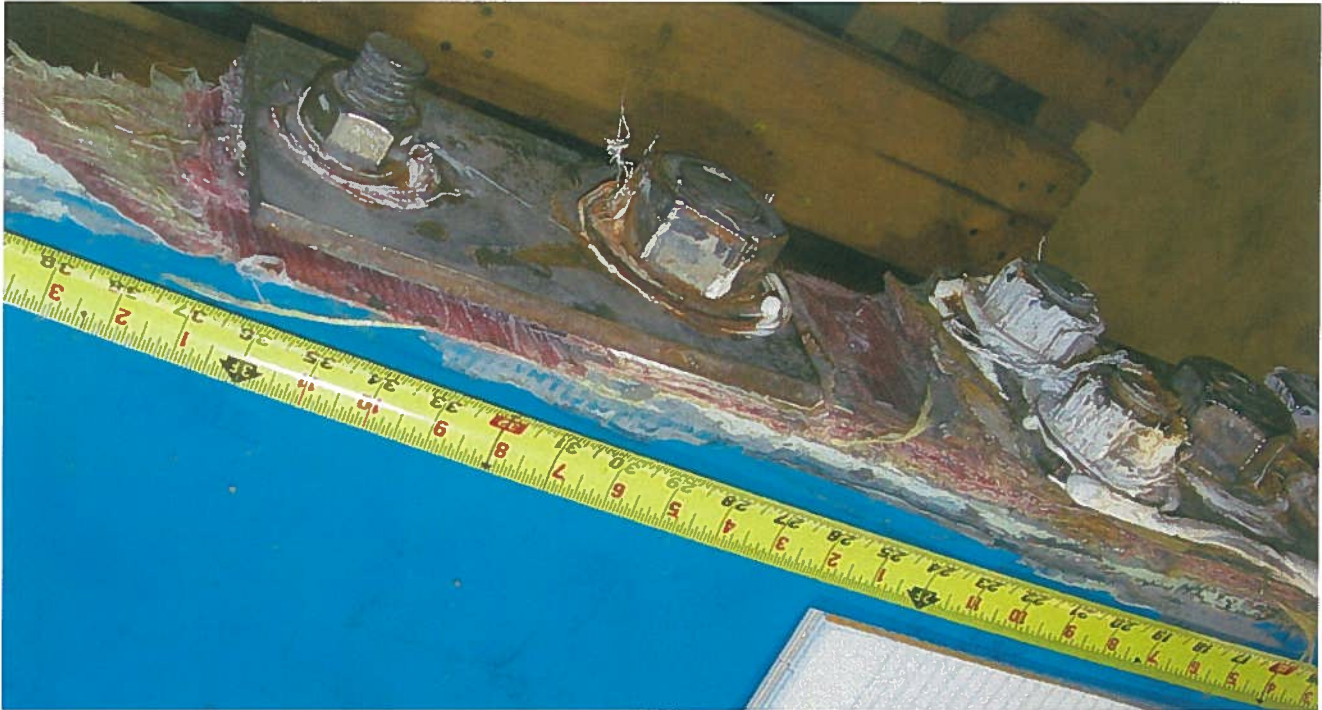
Wide backing plates distribute load through the hull more evenly. The S/V *Cynthia Woods*' backing plates were too narrow to adequately distribute the heavy load of the bulb keel. The failure location is on the backing plate to hull laminate.

**Photo.** Picture of multiple bolts through hull laminate. Notice the 3/8" thick backing plates are of similar width to keel fiberglass laminate width. For the backing plates to be effective, they should have been much wider than the keel. Backing plates the same width as the keel structure is bad practice; this design choice produces high stress concentrations at that point. Even the ABS Guide requires the minimum laminate to go 2" past the edge of the keel.

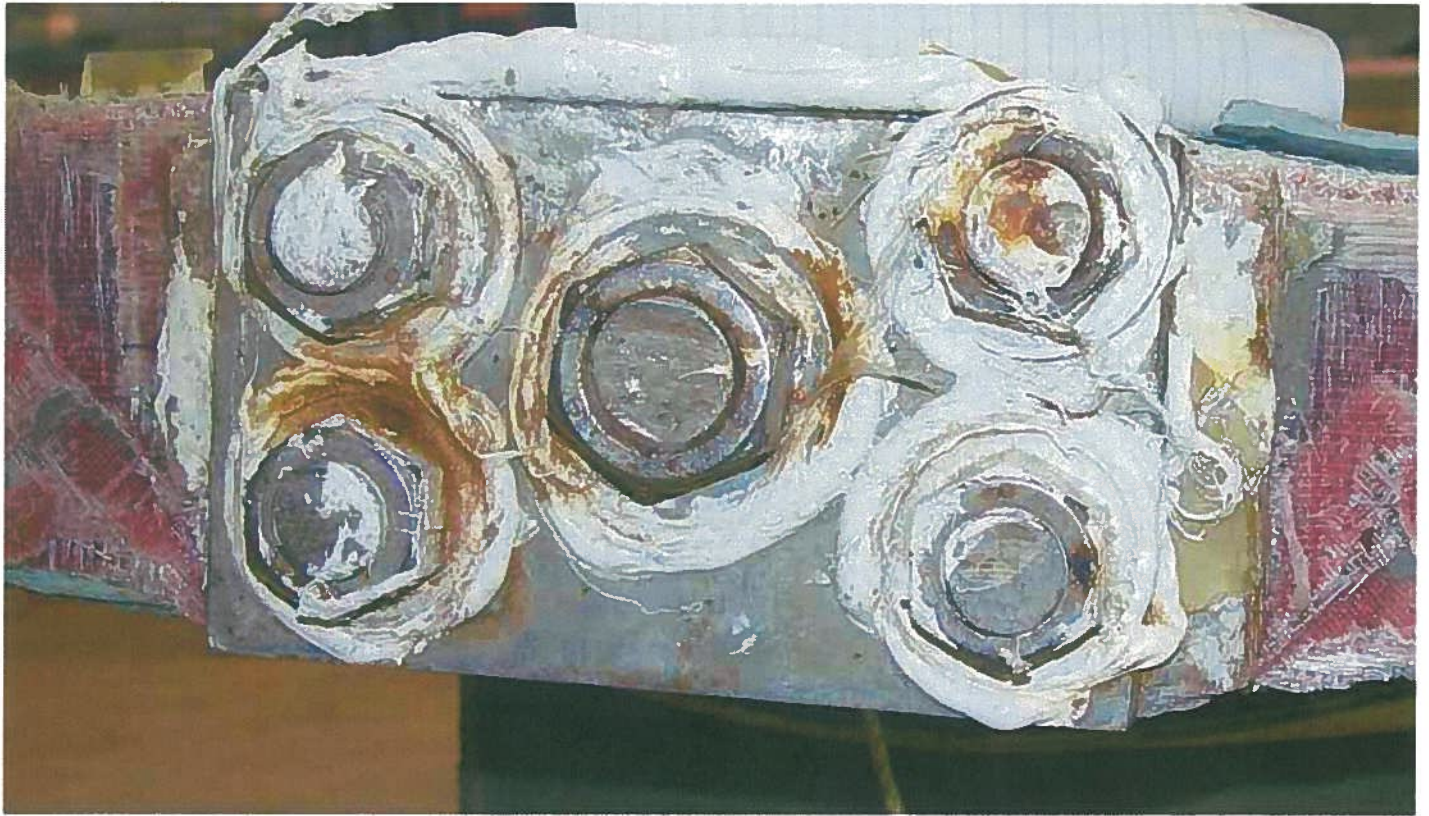
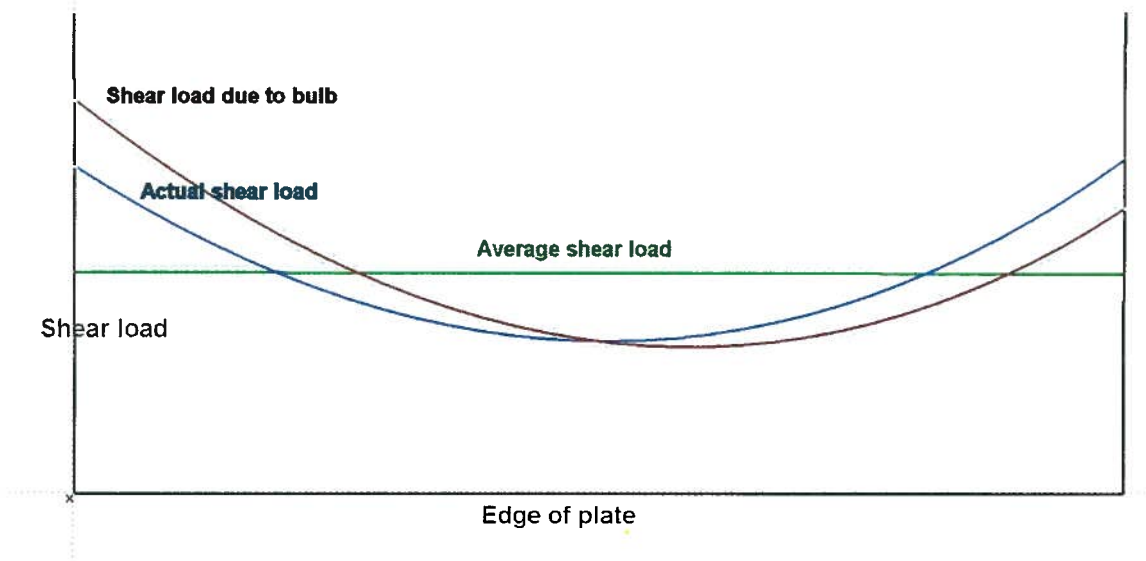
The center plate (plate #2) was very highly loaded due to the less than specified minimum hull thickness. The failure would start in a corner of those plates because the forward corner would have a higher load due to the bulb.

**Shear load diagram on edge of plate with picture of plate #2 directly above it for comparison purposes.**

Note the top right keel bolt has a washer overhanging the backing plate.

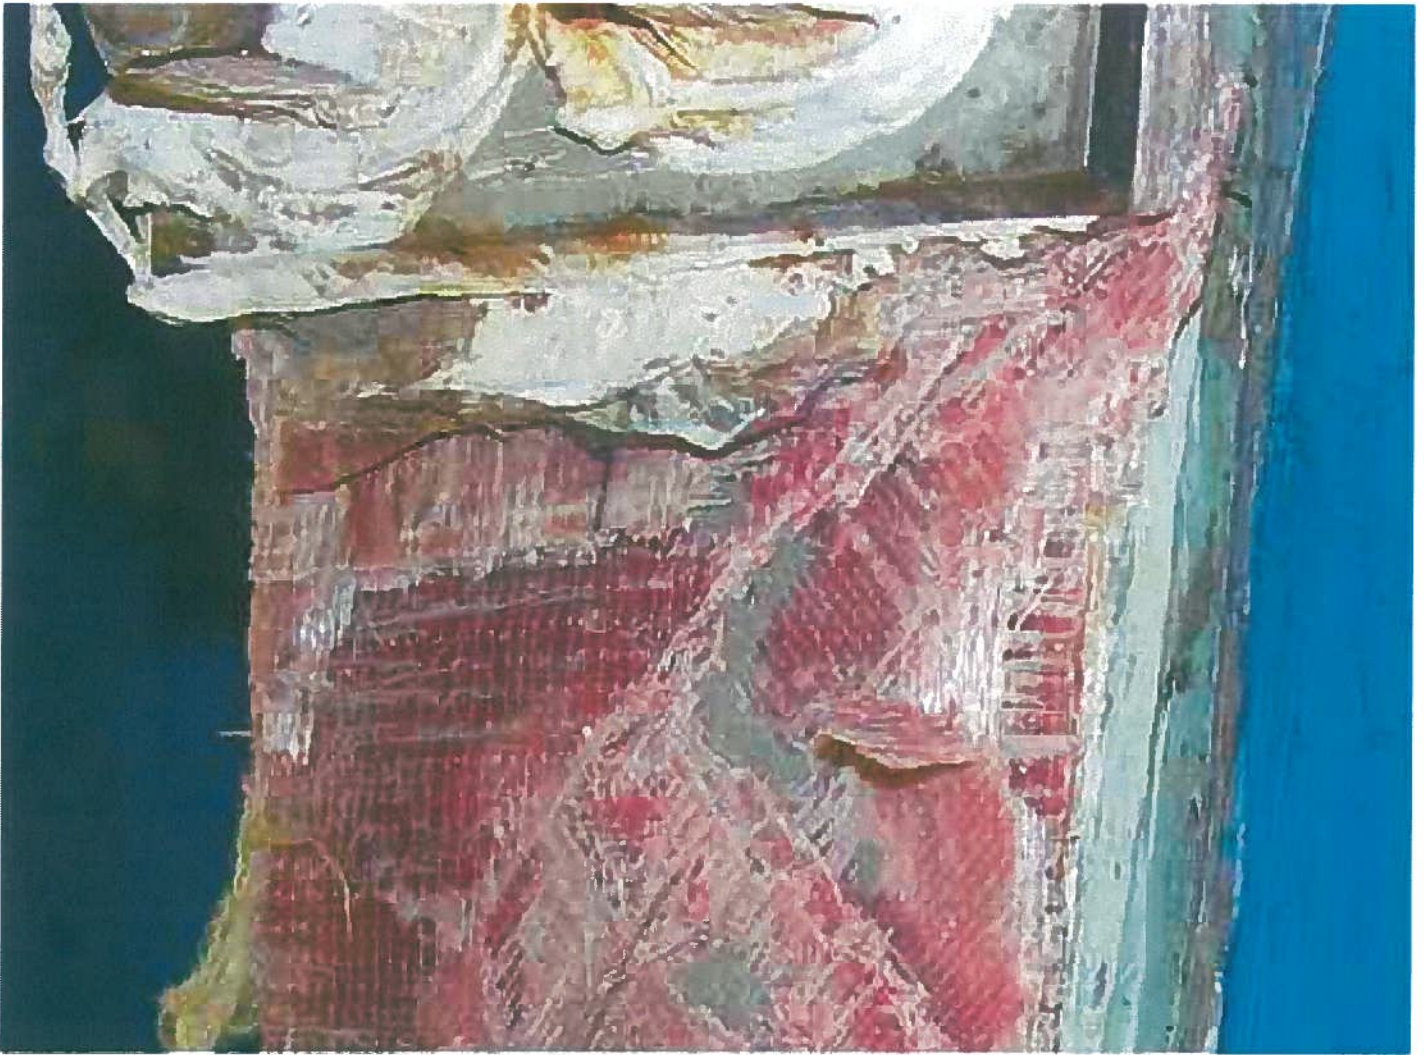
**Photo.** This is a photo at the point of the start of shear failure. Look right under the corner of the backing plate on the right side of the picture; it has a straight vertical side with no delamination.

What should be noted about this point of failure is it is a clean shear break.

It is between the two frames that hold the keel on. The loads, when grounding, rotate around this “middle” zone and have very low stress. The stresses from any grounding are on the front and back of the keel, not in the middle of the keel where this plate is located. The weight of the bulb, because of its aft location, causes the front of the plate to “dig-in” the more the boat heels.

This area was not one the areas repaired by the TAMUG students.

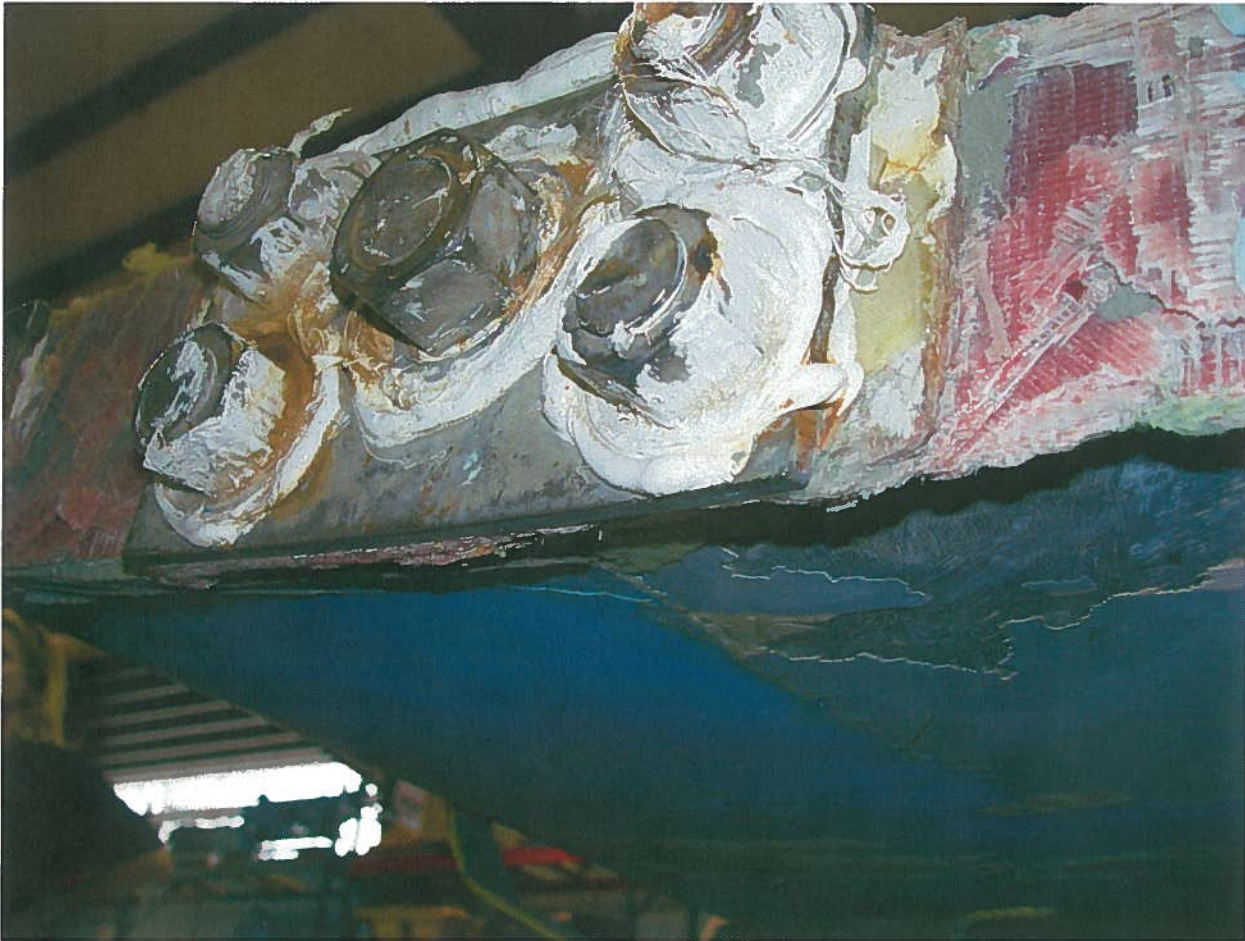
**Photo.** Another view of the port side of backing plate #2. Notice the vertical face through the laminate forward, before the failure of the keel goes catastrophic and starts to rip out of the boat. You can also see that because of the proximity of the backing plate edge so close to the keel bolts, that the tearing passes through the hole drilled for the bolt.

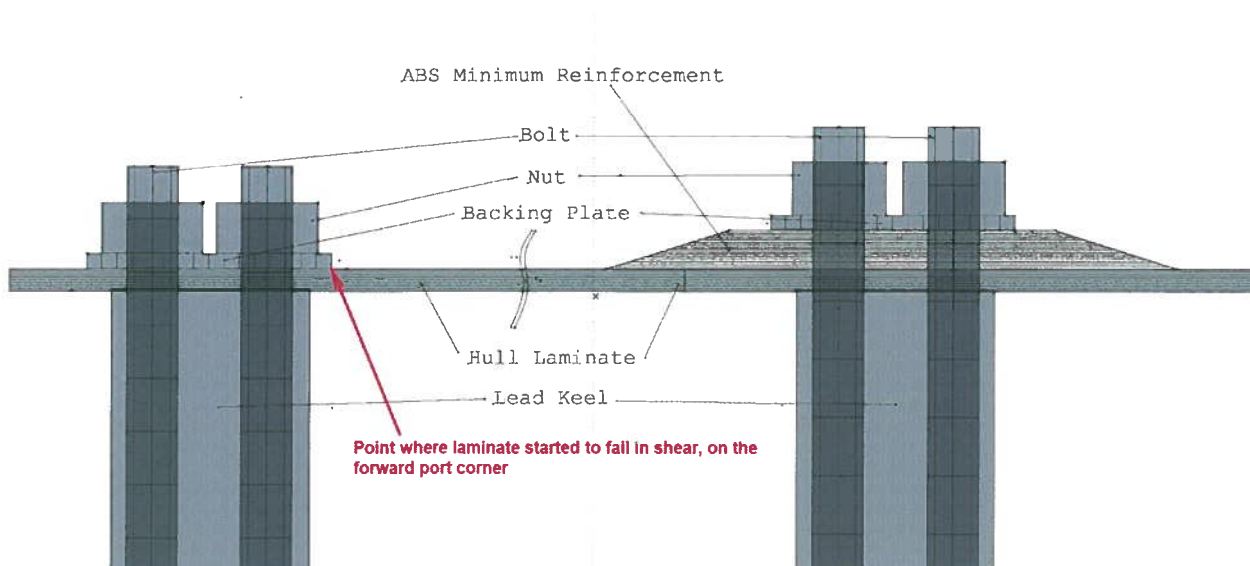
**This diagram shows another view of where keel failure started.**

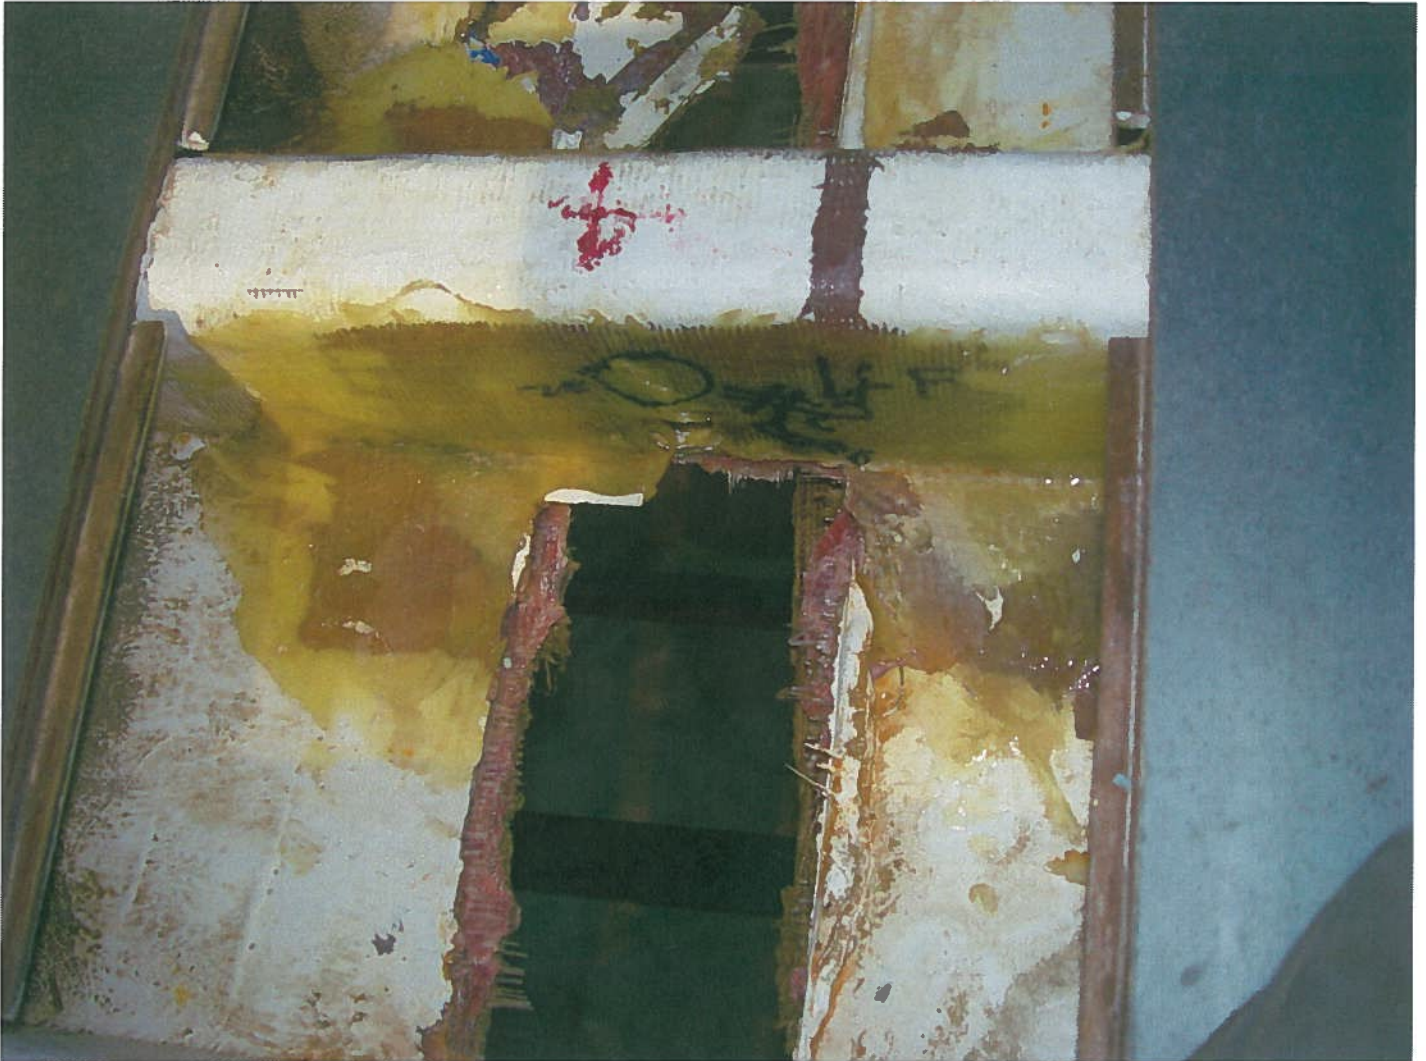
**Photo.** As a result of the grounding in March 2007, there were some cracks at the junction of the frame face and the hull where the glass turns 90 degrees. The replacement patch was two layers of 24 oz/yd.<sup>2</sup> woven roving. This and the following pictures show the repairs as a yellow, translucent color with some red and white underneath. This yellow color is an epoxy resin which is stronger than the red vinylester resin used for the hull.

The repairs were covering the small frame cracking, and are done to industry standard.

The important part is that all these repairs done by the TAMUG students are still intact, and that they had nothing to do with the keel's ultimate failure.

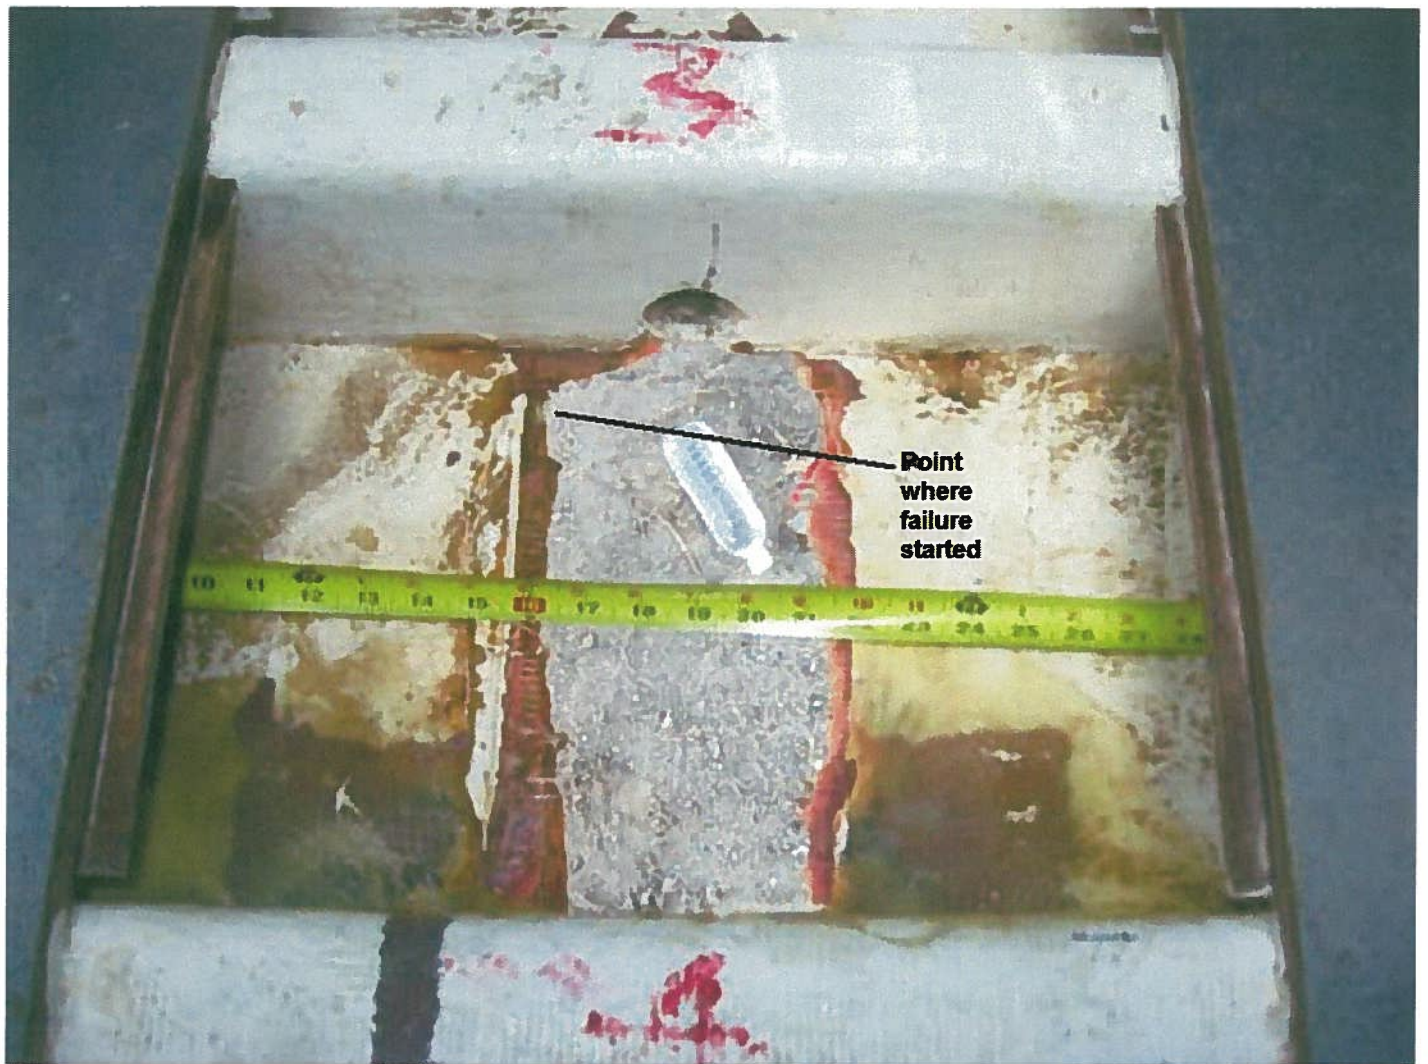
**Photo.** Inside the hull at the point where failure started. This area was not repaired by TAMUG students.

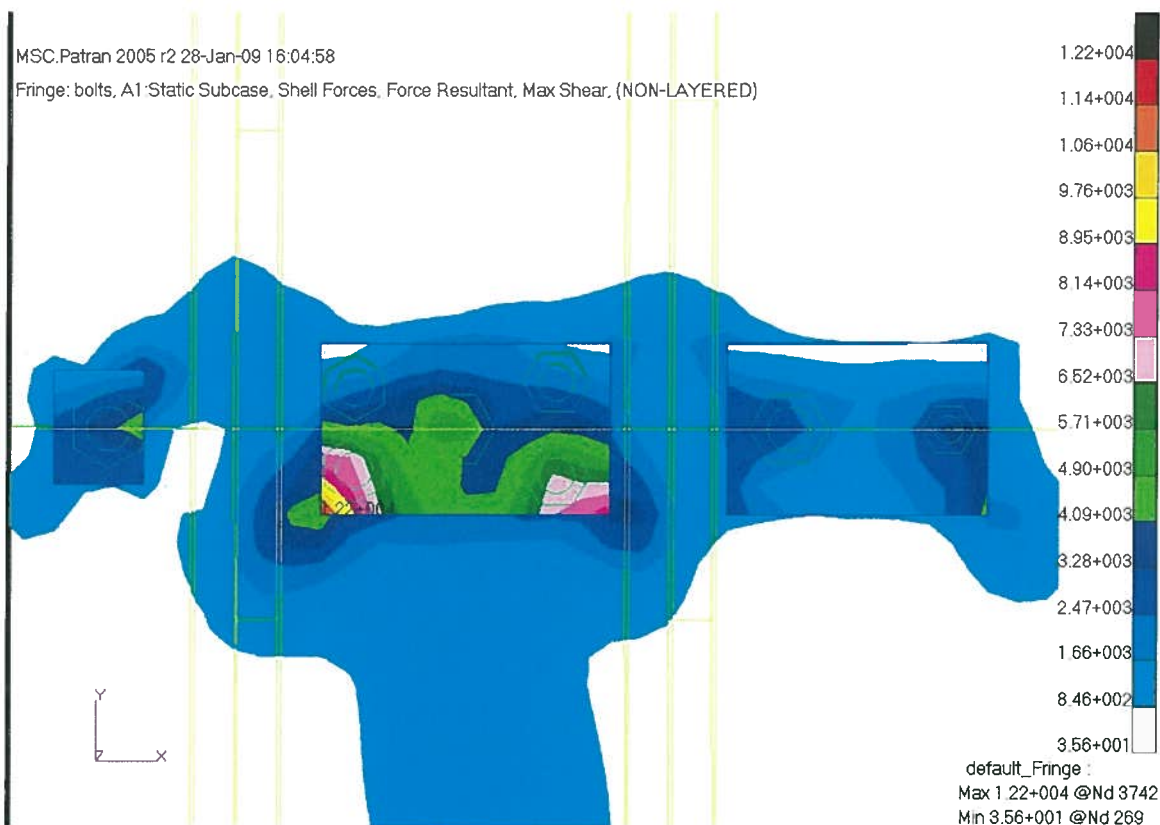
While all the plots on the Nastran finite element analysis show the hull is significantly under built, the one on page 16 (reproduced below) is the most significant, since it shows the mode of hull failure. The maximum load the ABS Guide allows is 50% of the materials' maximum shear strength. That number is 14,000 psi x 50% = 7,000 psi. The ABS Guide requires a safety factor of 4.0 for ultimate and 2.0 yield for keel bolts. The plot below has yellow showing and orange, red, and black on the forward tip of the middle backing plate. The backing plates for the keel are seen on the plot as the three rectangles. Reading from the scale on the right of the diagram shows that the black equates to  $1.22 \times 10^4 = 12,200$  lbs. on a broach load, or 90 degrees of heel. This 12,200 lbs. of load equates to 21,785 psi ( $12,200 \text{ lb./0.56 in.}^2$ ) of shear load is more than 3 times the boat's hull allowable design stress of 7,000 psi. The backing plate acted like an old-style can-opener (a shearing device), tearing through the hull on the port side, starting at the middle backing plate forward corner. The peak shearing load equates to an ABS hull thickness of 3.11 inches. The excessive thickness of the hull fiberglass is due to the use of very narrow backing plates. The thickness of the fiberglass could be reduced with the use of wider backing plates.

**Shear force diagram on the hull. This diagram shows the failure mode for the *S/V Cynthia Woods*. The failure started on the left front corner of the middle backing plate.**

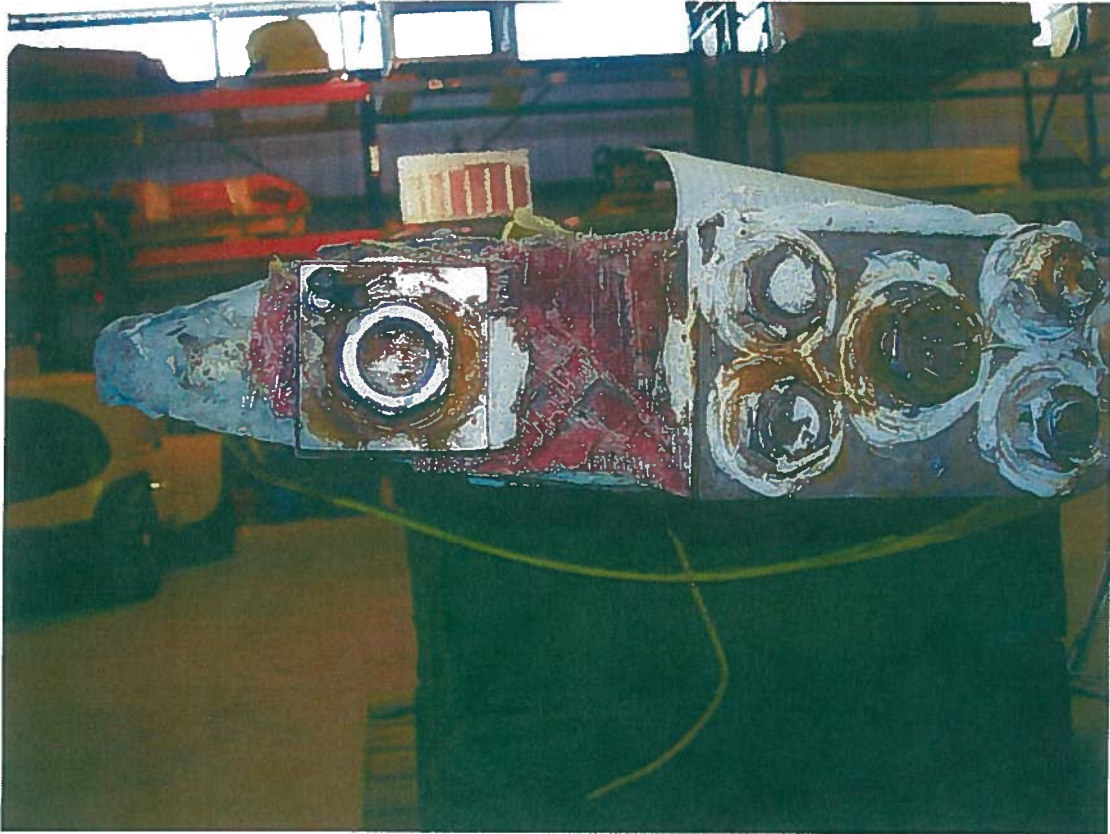
**Figure 8.0.1 – View of Forward & Middle Backing Plates**

Note the washers of the outboard bolts overhanging the corners of the middle backing plate. This is a good indication that the backing plates are neither wide enough or long enough to distribute the keel bolt loads to the hull shell & keel floors. Standard airframe practice is to use a minimum edge distance of  $2D + 0.06"$  (Reference #8), which is not met by the corner bolts shown above.

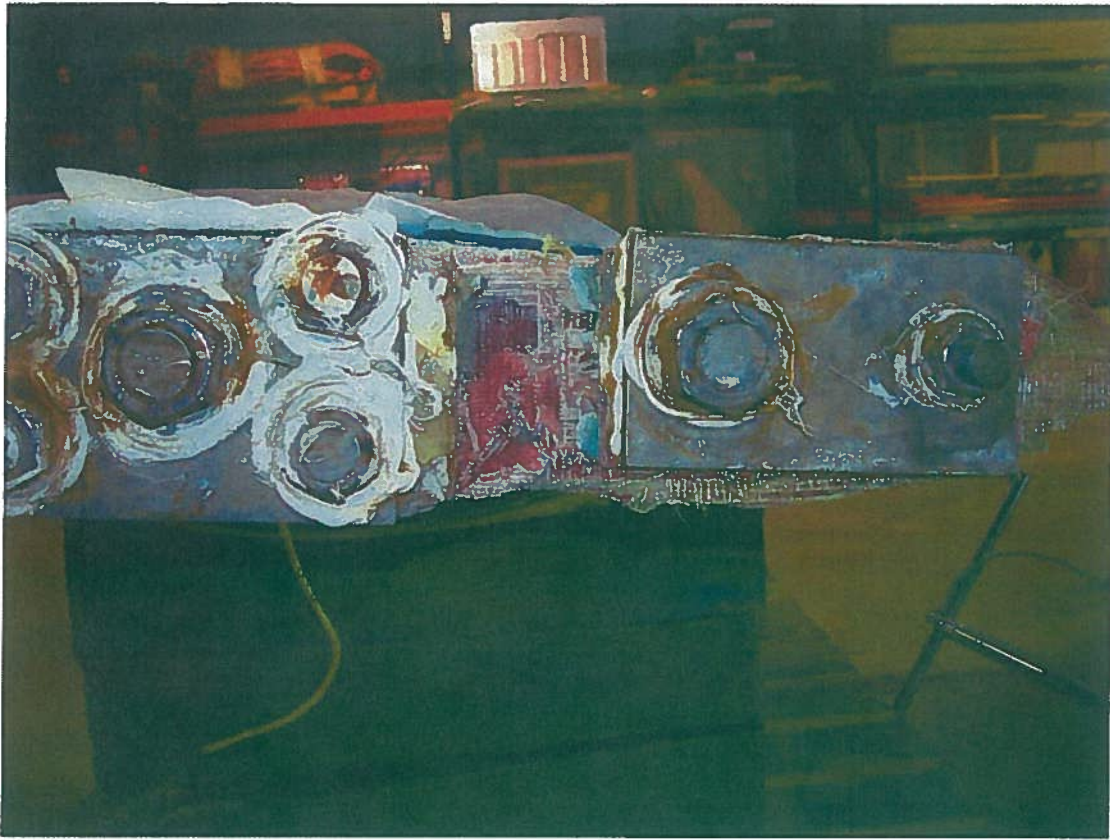
**Figure 8.0.2 – View of Middle & Aft backing Plates**

Again, this picture shows the clean cut vertical shear of the hull shell at the edge of the middle backing plate. The failure of the hull shell at the aft backing plate is not so clean along the edge of the plate, indicating that the hull shell had failed along the edge of the middle plate first & propagated forward & aft (Note – Figure 7.0.1 verifies this with the ragged edge show by the forward plate).

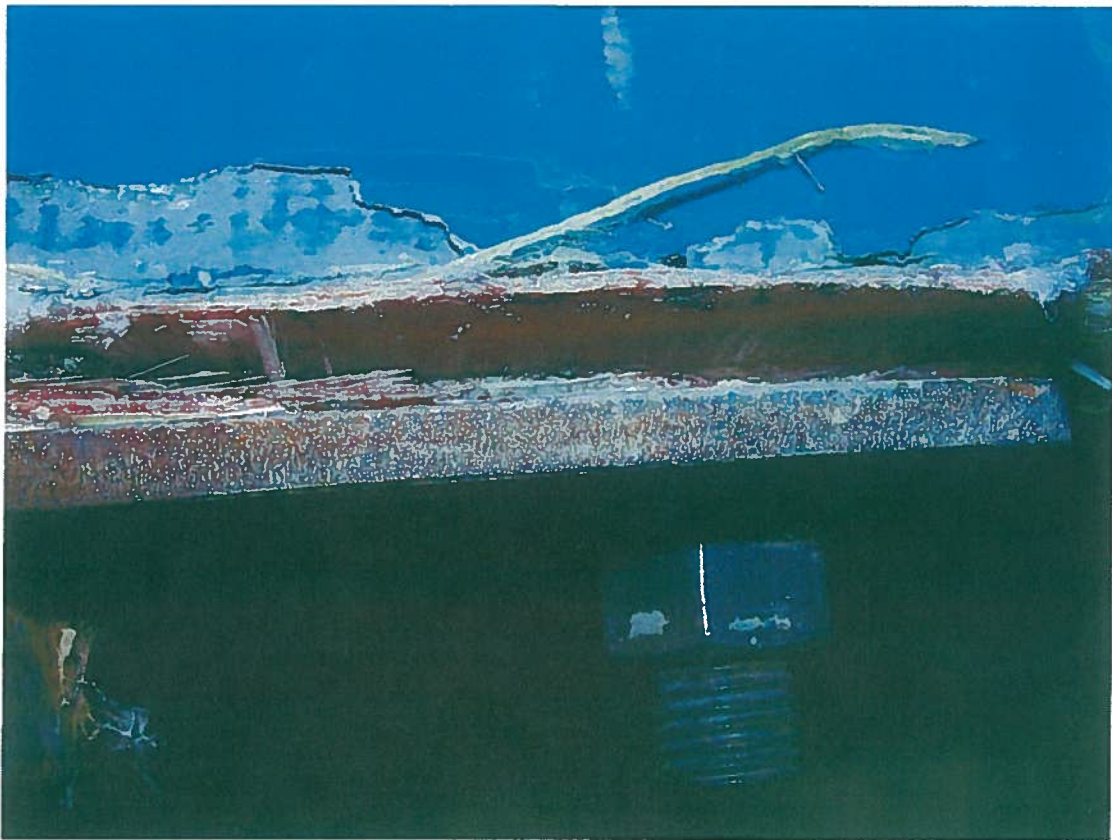
**Figure 8.0.3 – Delamination of the Hull Shell**

In this picture, the delamination of the hull shell can clearly be seen. It is likely that this delamination occurred prior to the shearing of the hull shell. Once the hull shell laminate is delaminated & weakened, the laminate fibers will fracture. This delamination was most likely caused by the repeated tension & compression loading over time (fatigue) at the root of the keel due to tacking & other sailing maneuvers.

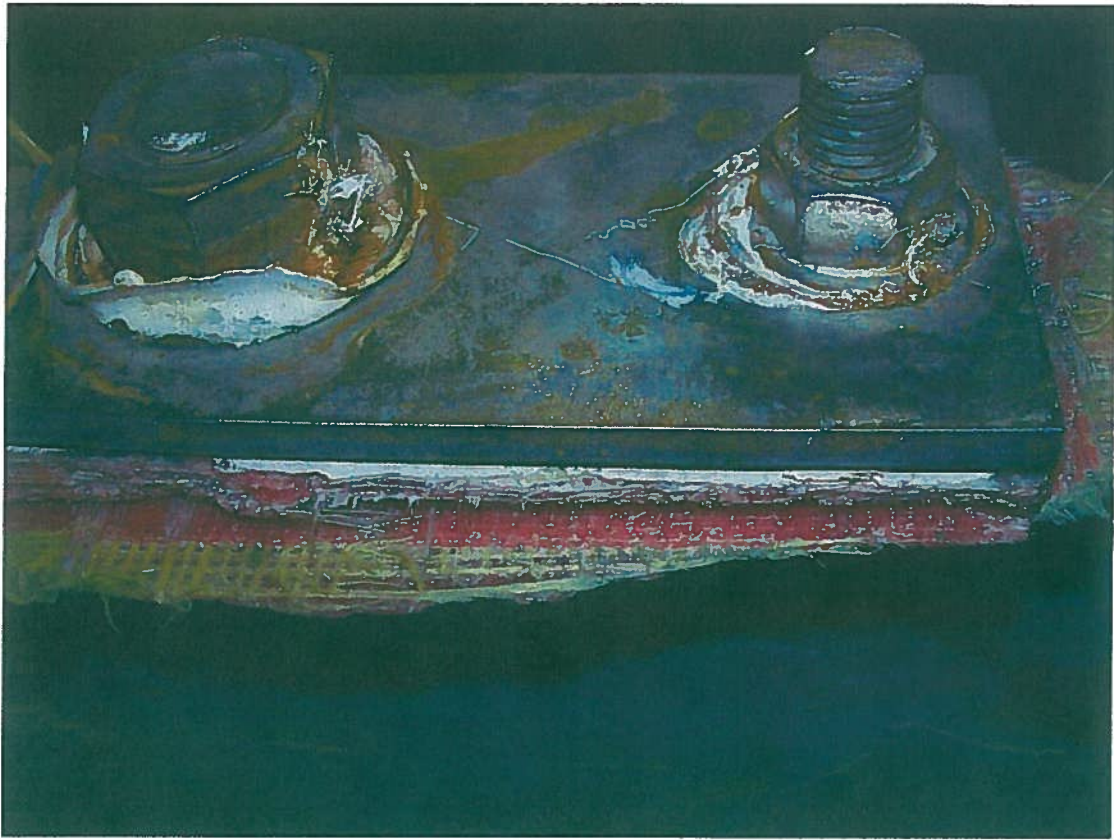
**Figure 8.0.4 – Delamination of the Hull Shell**

Another photograph showing delamination of the hull shell at the aft backing plate.
