# Appendix E

## Dobroth Design, Inc. Science Report

*S/V Cynthia Woods*

**The purpose of this Science Report is to examine why the keel-to-hull joint of the S/V *Cynthia Woods* failed catastrophically, thereby causing the keel to fall off the vessel during a race. The firm was retained by Texas A&M University at Galveston to determine the cause of the accident.**

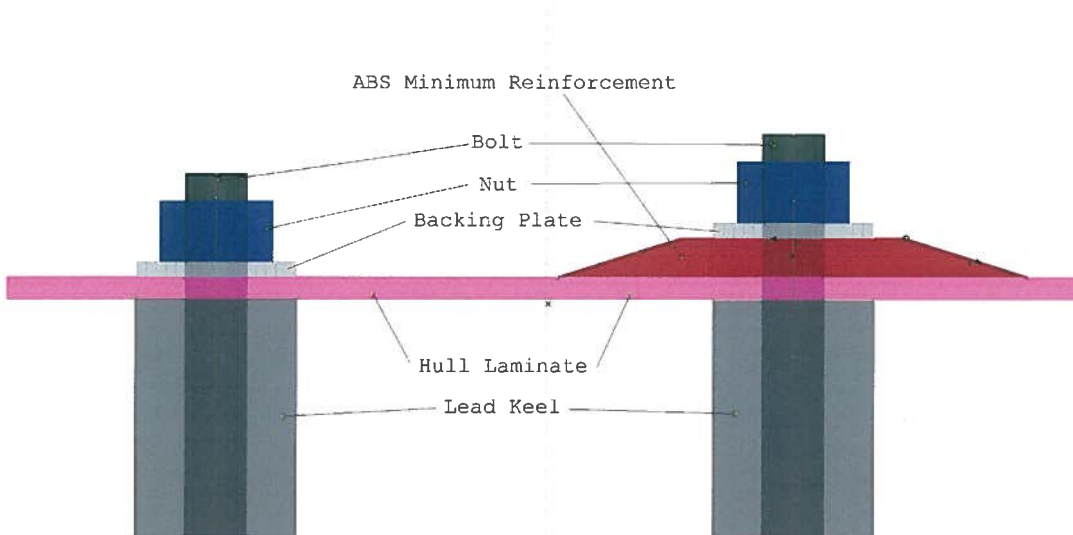
**Diagram of forward keel bolt (backing plate #1)**

**As-Built Cynthia Woods**

**Absolute Minimum ABS Laminate**

Cross section at a pair of split bolts (split from centerline) like those that were used at plate #2. The left shows the S/V *Cynthia Woods* as-built. It is at the edge of the backing plate that the keel laminate first failed. The diagram on the right above shows the minimum laminate that is required by the ABS Guide.

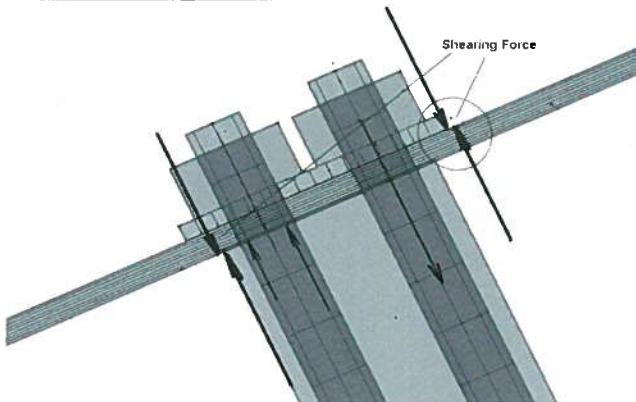
Cross-section @ split bolts

Load on 2 split bolts @ SS ult. strength, center plate	125020 lbs
Shear load center plate edge corners	12200 lbs
Factor of Safety	0.32

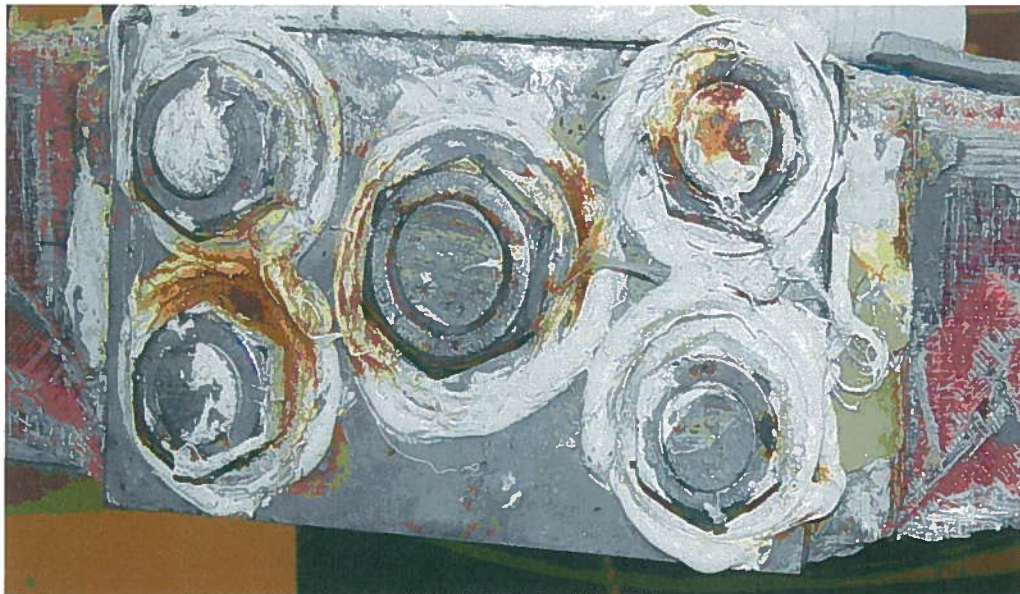
Note: small width of backing plate with washer hanging over backing plate

**Picture showing small backing plate with washer overhanging. 15 % of the hull area cut out under plate.**

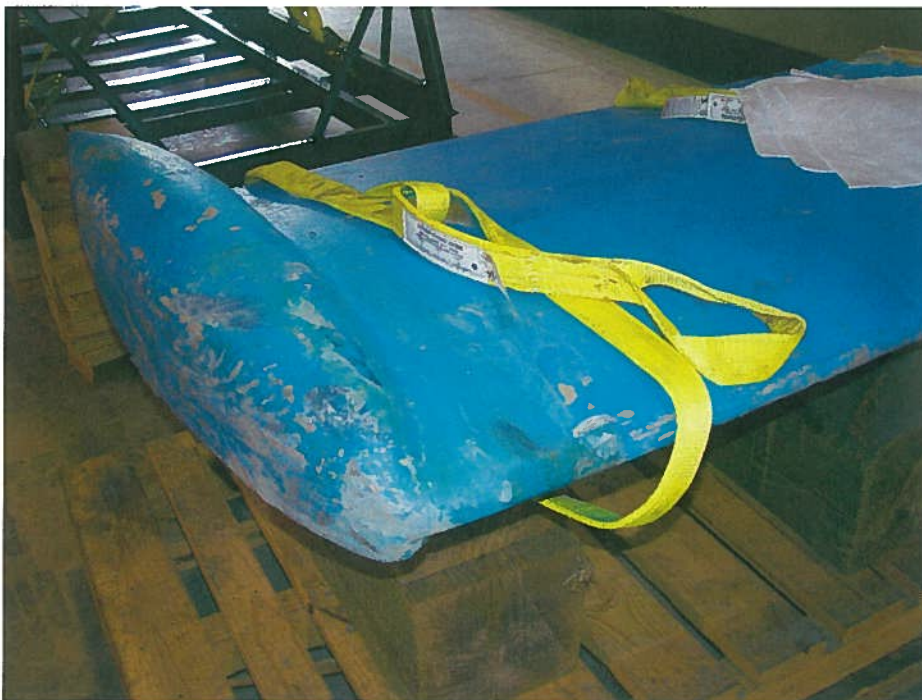
**Diagram showing the damaged locations after grounding.**

The damage to the lead is isolated to forward of the forward keel bolt and aft of the aft keel bolt. There is very little lead area aft of the last keel bolt and it is easily deformed. This type of damage is very common in groundings with a lead keel.

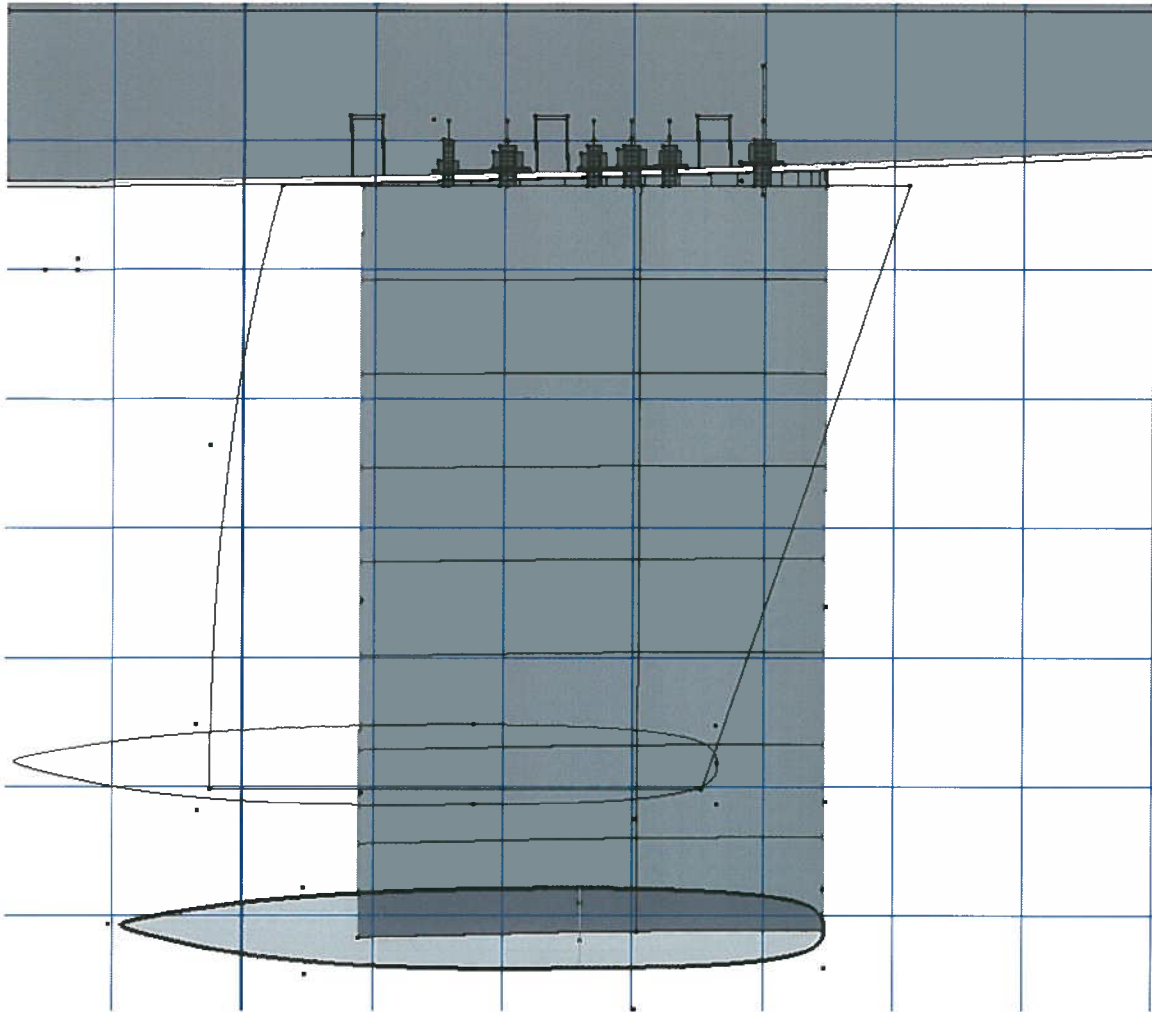
**For comparison purposes, the white keel is on the original Cape Fear 38. The gray keel is on the later hulls, such as the hull installed on the *S/V Cynthia Woods*. The framing of both versions did not seem to change. The later deeper keels created much higher bending and grounding loads over a smaller hull area.**

For some inexplicable reason, the earlier production of Cape Fear 38 boats had a thicker fiberglass hull laminate around a shallow keel and the later production Cape Fear 38 boats (of which the *S/V Cynthia Woods* was one) had a thinner fiberglass hull laminate around a deeper keel. This design/construction is totally illogical.

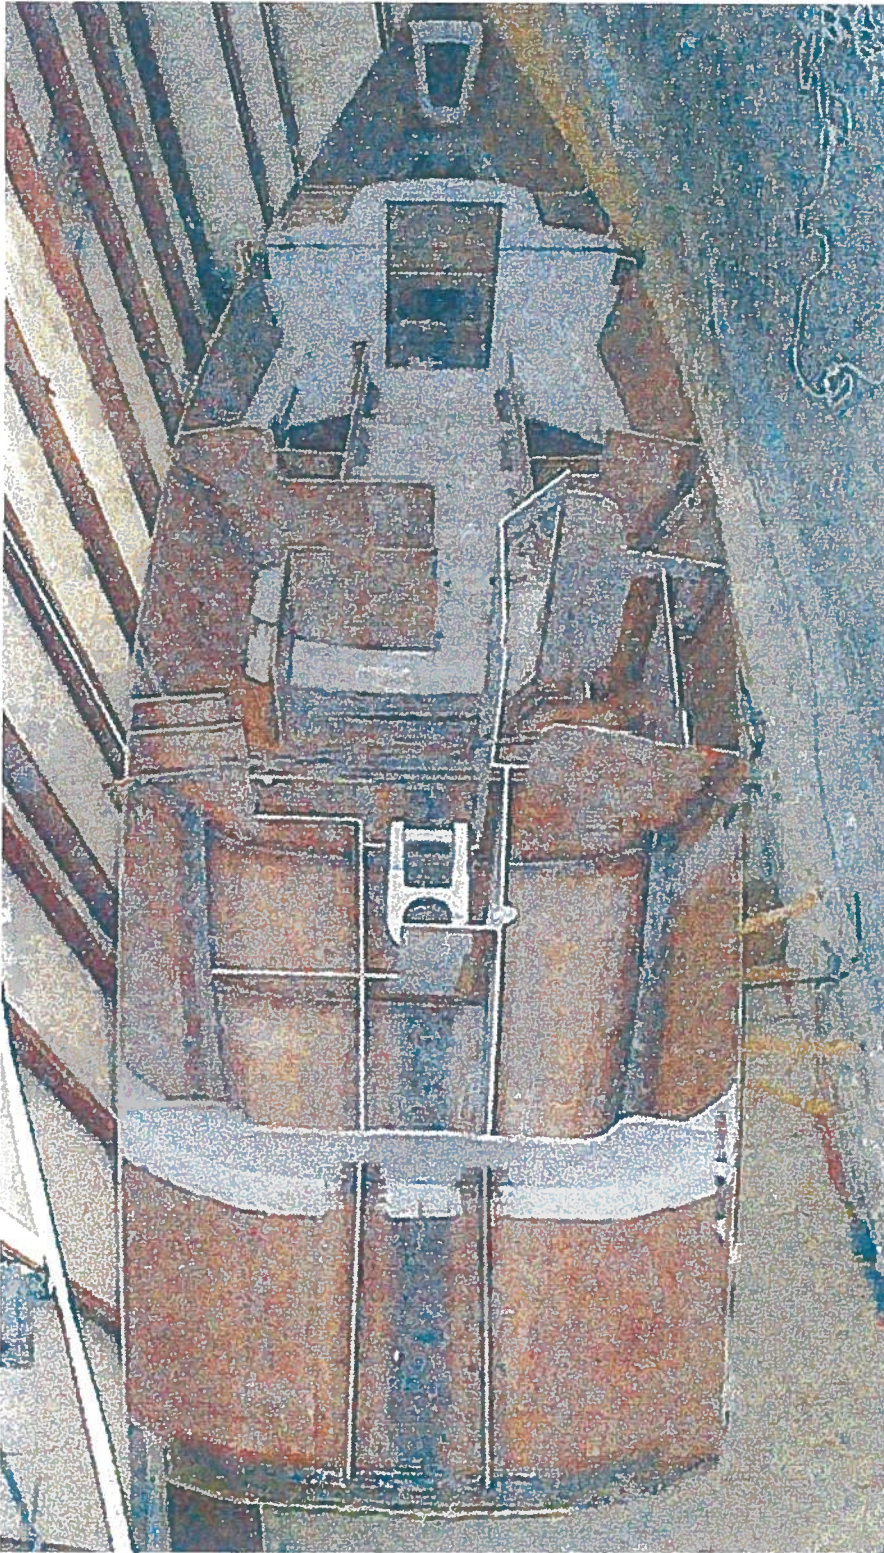
Picture of Hull Number One with One Inch of Fiberglass Laminate

**Photo.** This is an overhead picture of hull number one. The dark strip down the centerline of the yacht is where the core has been removed and has been replaced with solid fiberglass. The *S/V Cynthia Woods* had no core, and was solid. Peter Ross, the builder of the first hull, said the solid down the centerline was one inch thick where the keel was attached.

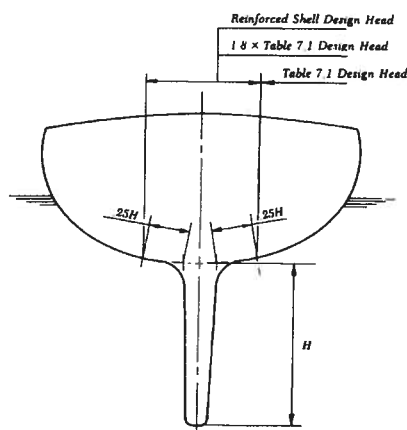
**ABS Figure 7.2 Transverse Section**

The additional ABS Guide reinforcing laminate was not present in the *S/V Cynthia Woods*.

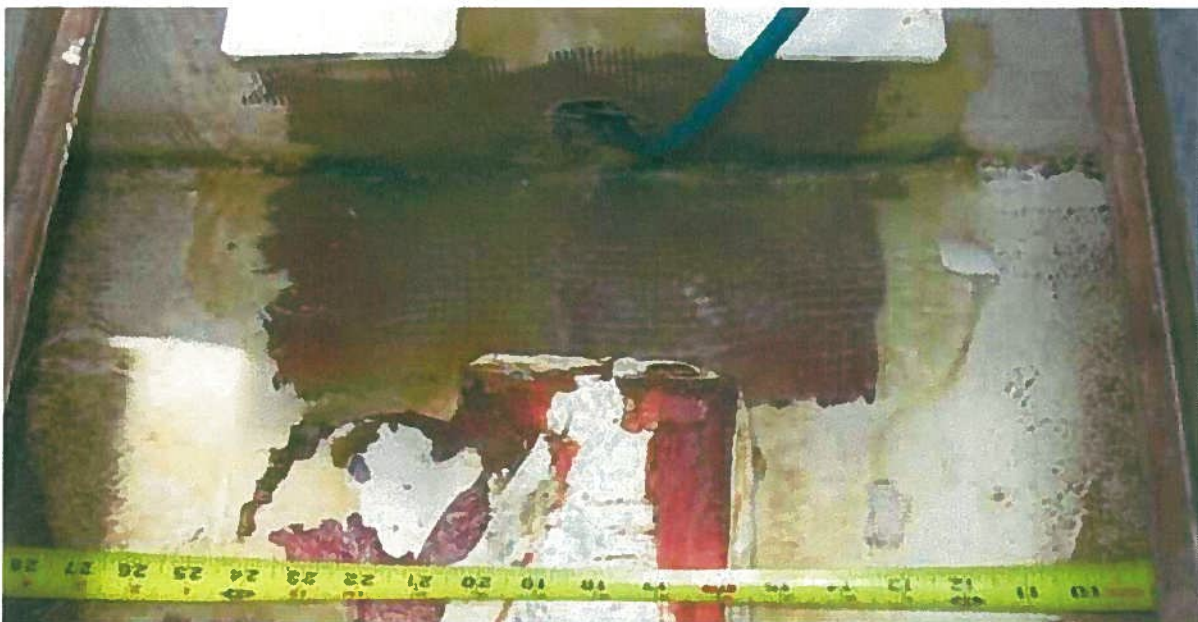
The keel failed in shear.

The center plate (plate #2) was very highly loaded due to the less than specified minimum hull thickness. The failure would start in a corner of those plates because the forward corner would have a higher load due to the bulb.

The failure was on the port (left) side due to the boat being on port tack.

What should be noted about this point of failure is it is a clean shear break.

**Photo.** Inside the hull at the point where failure started. This area was not repaired by TAMUG students.

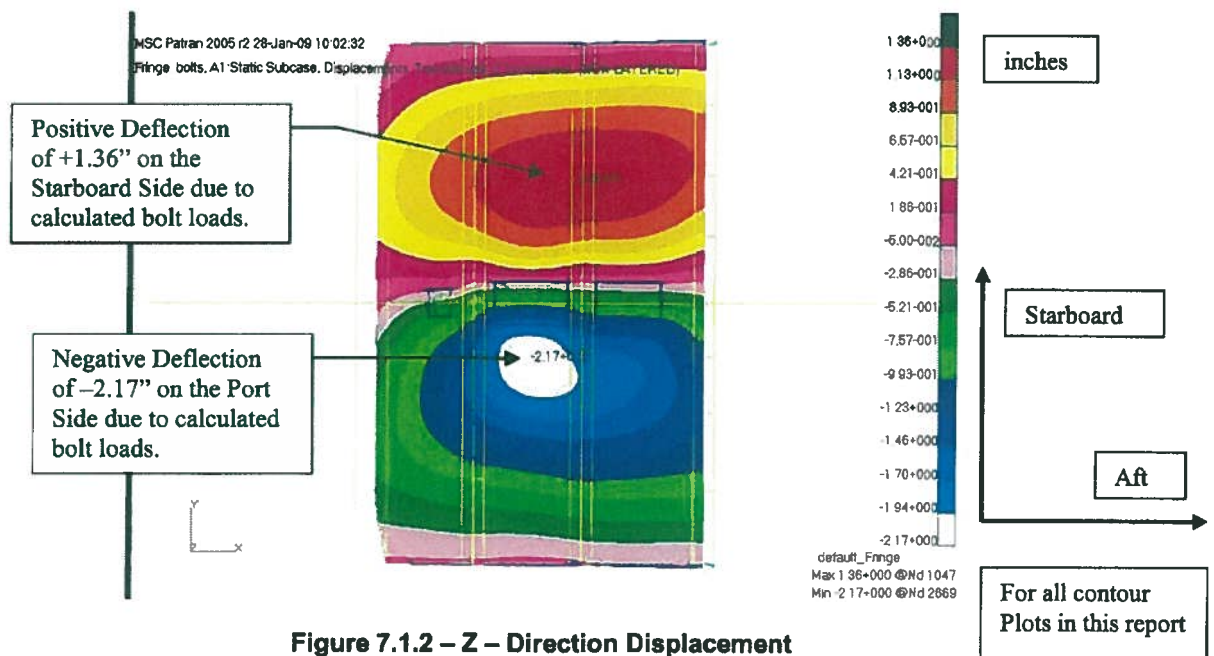
**Figure 7.1.2 – Z – Direction Displacement**

For Loadcase #1, these keel bolt loads were applied directly at the keel bolt locations in the proper direction (tension pulling down on the bolt – weather side), giving the following results.

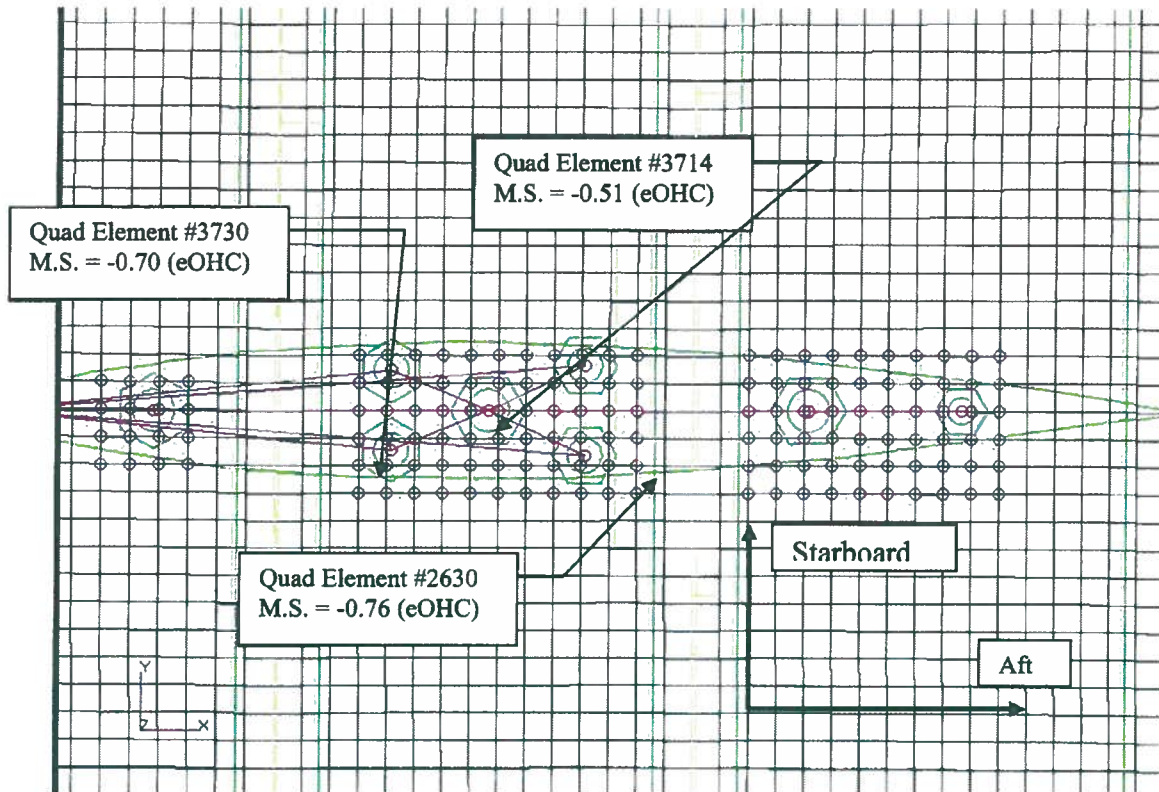
Figure 7.1.9 – Locations of Most Critical Elements

Margin of Safety (M.S.) calculations using CLAM for most critical hull shell elements adjacent to the keel bolts for limit loads, showing that the hull shell & the hull shell plus the stainless steel backing plates are significantly under designed (negative margins of safety). The results of these margin of safety calculations follow:

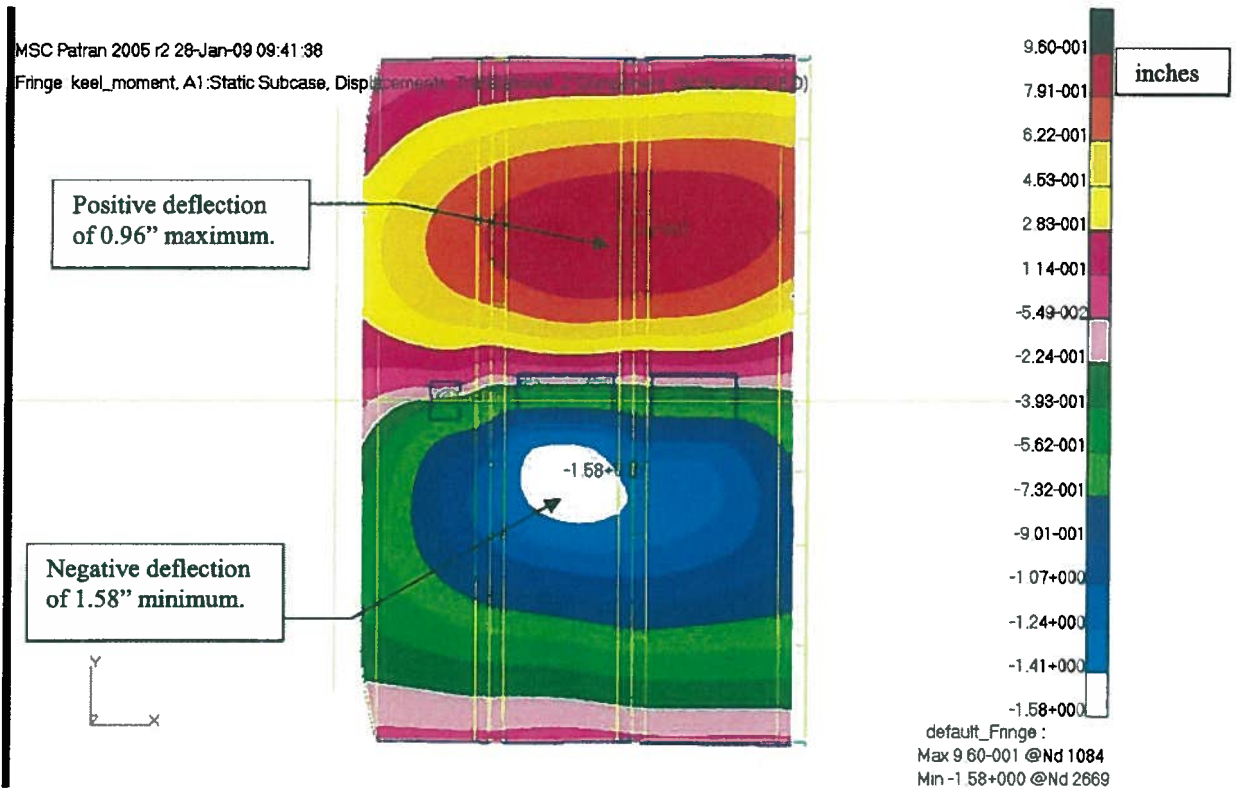
Figure 7.2.1 – Z (Vertical) Displacement

Loadcase #2 is the 90 degree keel weight applied at the center of gravity of the keel. This load is beamed to the keel bolt locations using rigid body elements (RBE3's) to distribute this load, according to the back-up structure stiffness, to each keel bolt. The keel bolt loads &, thus, the deflections are lower for this loadcase, since the hull shell/floor structure combination is not treated as a rigid body but is flexible & attempts to give a truer representation of the actual Cape Fear 38 hull structural stiffness. The results for this loadcase is as follows:

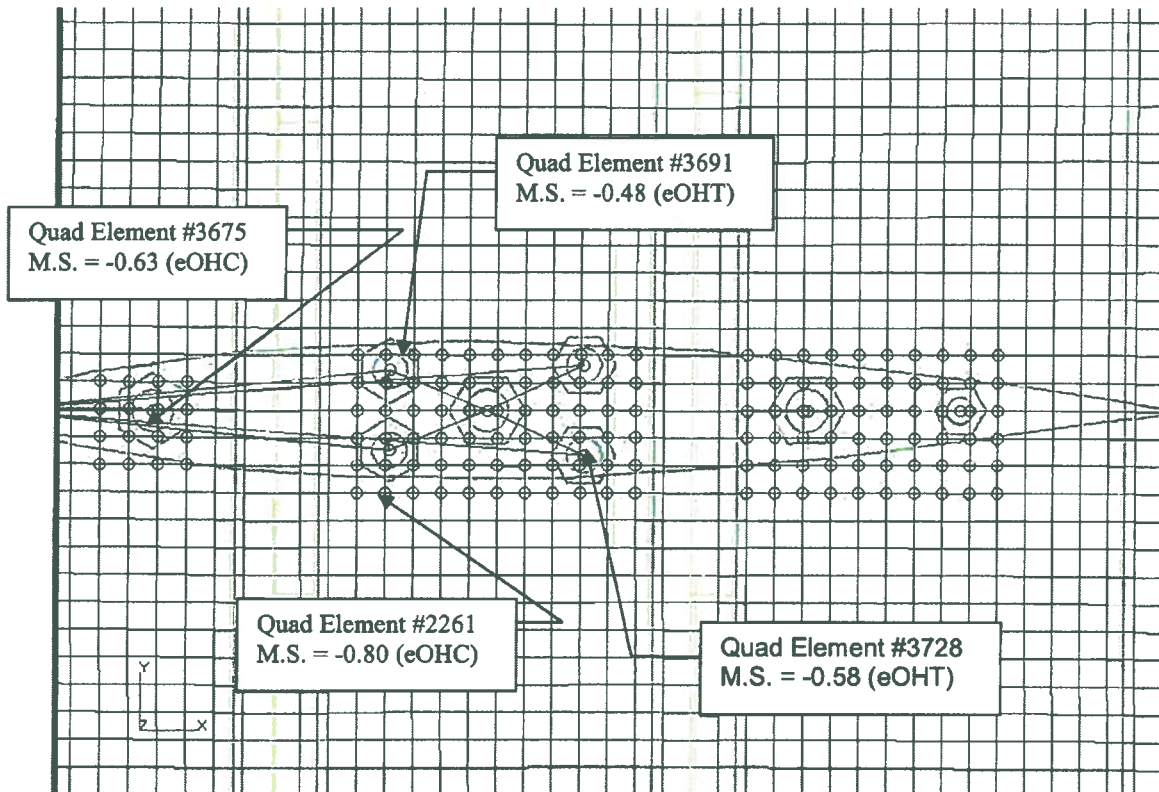
Figure 7.2.7 – Locations of Most Critical Elements

Margin of Safety calculations using CLAM for most critical hull shell elements adjacent to the keel bolts for limit loads, showing that the hull shell & the hull shell plus the stainless steel backing plates are significantly under designed (negative margins of safety). The results of these margin of safety calculations follow:

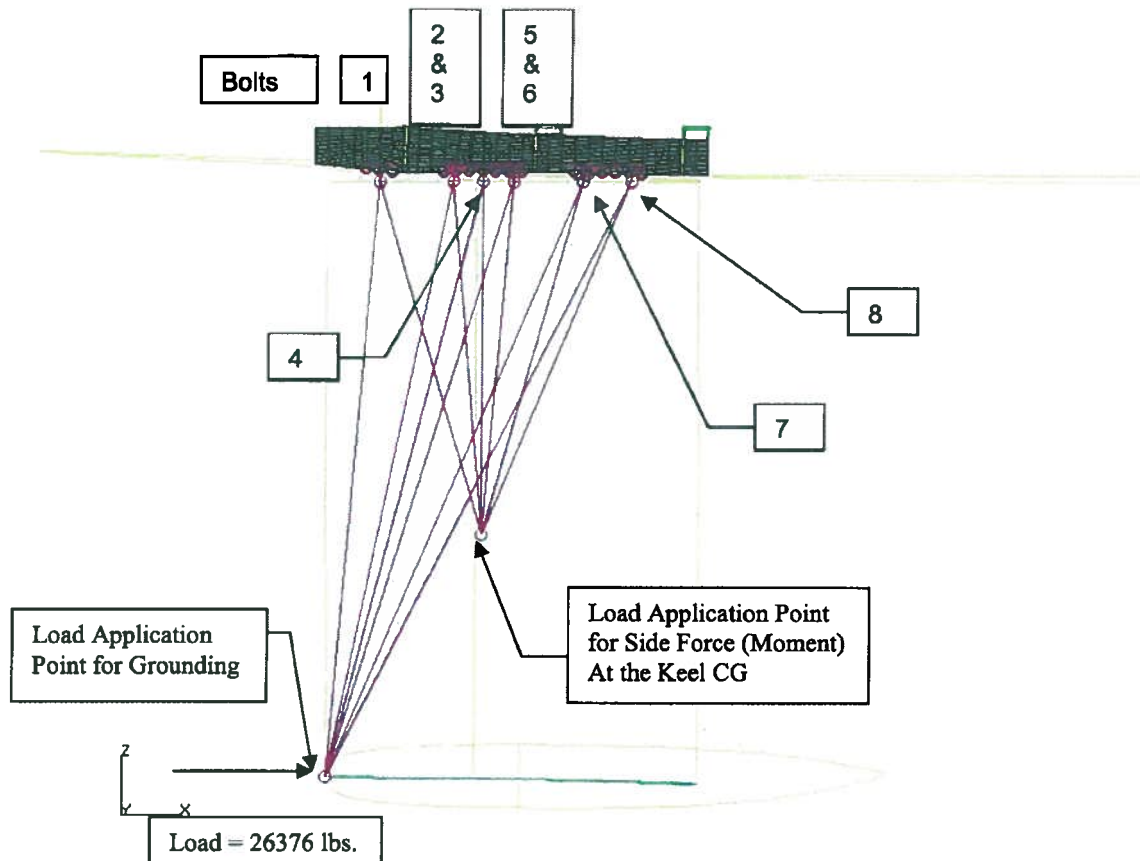
Figure 7.3.1 – Floor Structure, Applied Load & Keel Bolt Locations

Loadcase #3 is the grounding loadcase with the grounding load applied at the forward tip of the keel. This load is beamed to the keel bolt locations using rigid body elements (RBE3's) to distribute this load, according to the back-up structure stiffness, to each keel bolt. The results for this loadcase is as follows:

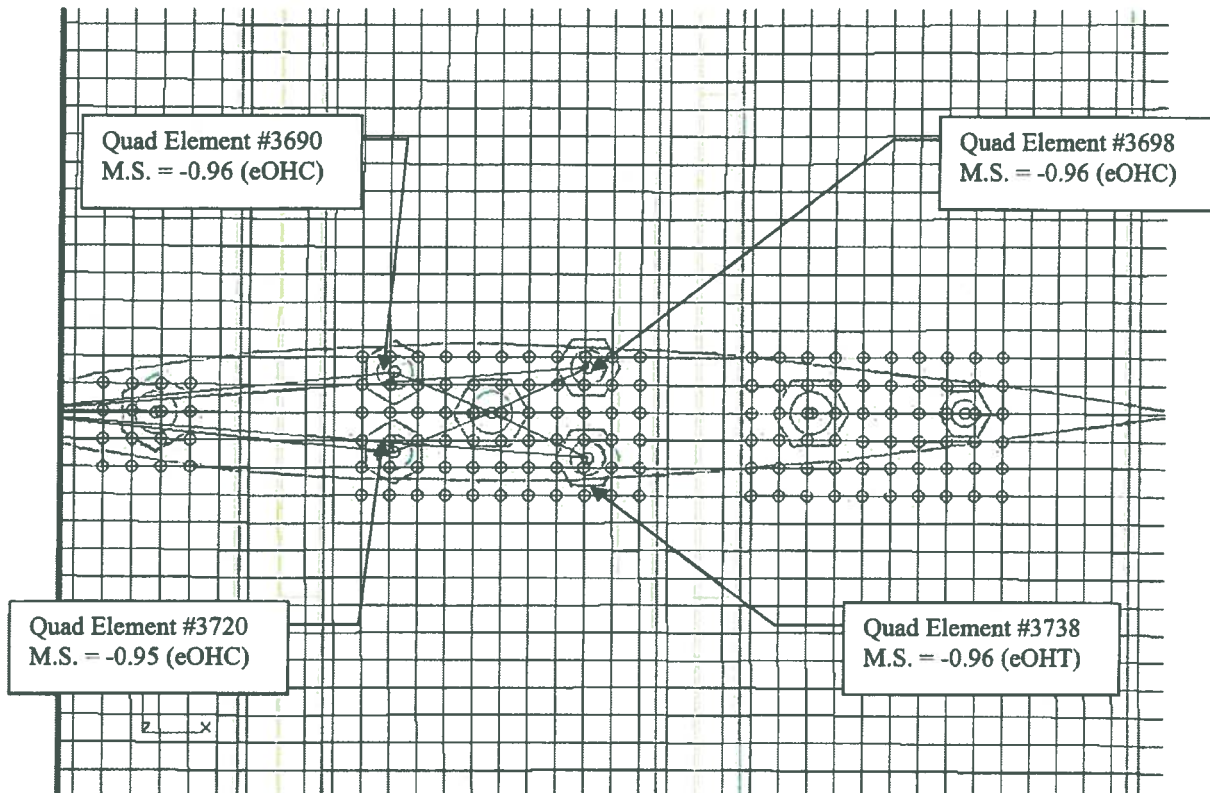
Figure 7.3.8 – Locations of Critical Elements for Grounding Condition

Margin of Safety calculations using CLAM for most critical hull shell elements adjacent to the keel bolts for limit loads, showing that the hull shell & the hull shell plus the stainless steel backing plates are significantly under designed (negative margins of safety). The results of these margin of safety calculations follow:
